# Radar and resistivity surveying in Saschiz

Report for Atelier Undaverde srl.

Budapest, 2019. April

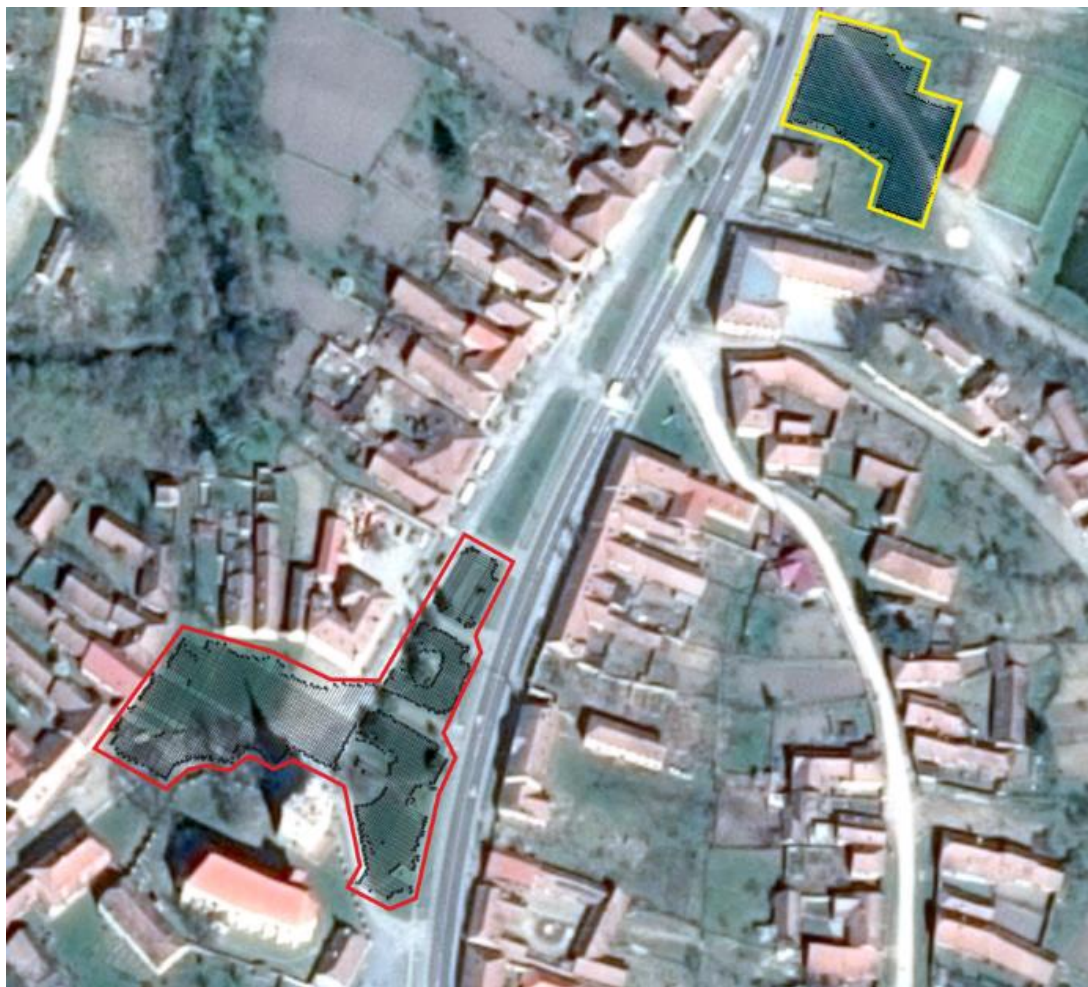
Figure 1. Location of the survey areas in Saschiz.  
Red line: main square, yellow line: "Parking area"

We made measurements in two areas in Saschiz: 1) in the main square of the village and 2) in an empty land beside the school along the road No.13 (Fig. 1). The second area from now will be called „Parking area”. In both areas we applied two methods: 1) Ground Penetrating Radar (GPR) and 2) Resistivity measurements. We made the GPR survey using instrument Mala Ground Explorer with 160 MHz shielded antennas, and we made the resistivity measurements with instrument ARES. We made the surveying in local coordinate system, which was transformed into Stereo70 coordinate system by measuring the Stereo70 coordinates of a few fitting points using RTK GPS. We made the GPR survey along lines in two perpendicular directions. In the main square in WNW-ESE direction the spacing between the survey lines was 0.5 m, and in NNE-SSW direction the spacing was 1 m (Fig. 1). In the Parking area in NNE-SSW direction the spacing between the survey lines was 0.5 m and in the perpendicular direction it was 1 m. The resistivity measurements were also made along lines. We measured only a few lines in order to check the results of the GPR survey, and especially to obtain information from below the penetration depth of the radar waves.
